# Thermography in a Distribution Operator, Common Real Problems

**Jacob G. Fantidis<sup>1\*</sup>**

<sup>1</sup>*Department of Electrical Engineering, Eastern Macedonia and Thrace Institute of Technology, Kavala, Saint Loucas 65404, Greece.*

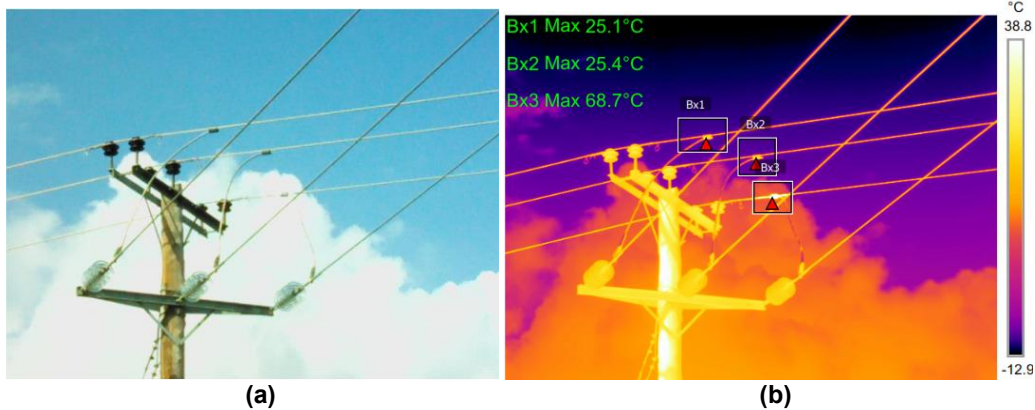
The IRT inspection procedure in the field based on the general rule that, usually in the distribution operator networks, owing to the presence of a three-phase current, there is the same electrical equipment three times. This equipment operates simultaneously in similar conditions. The direct comparison of these objects helps a lot the fault evaluation via the  $\Delta T$  criterion. One of the most typical failures in the electrical networks has as reason the presence of some bad or loose connections. (Fig. 2a and b) is a representative example of this category. The loose connection has as a result excess heat (caused by increased resistance) and the priority of the fault is 1. All the presented examples based on the use of the Flir T 640 thermal camera which is the most common thermographic system in the HEDNO S.A.

Fig. 2. (a) The visual photo of the loose connection and (b) the thermal photo which reveals the fault

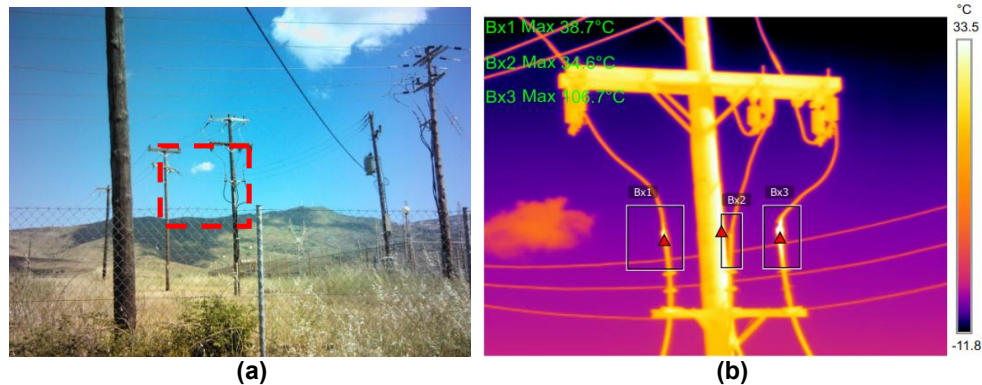
Another critical object is the connection point between underground and aerial cables. Fig. 3a

shows the visual image of the first pole outside of the HV/MV substation. With the help of the IRT the thermographer has found the problematic point (Fig. 3b). General the first pole outside of the HV/MV substations is critical equipment and checked with the thermal camera at least every three months.

Fig. 3. (a) The visual photo of the fault connection between underground and aerial lines (b) the fault in the same point with the help of the thermal photo

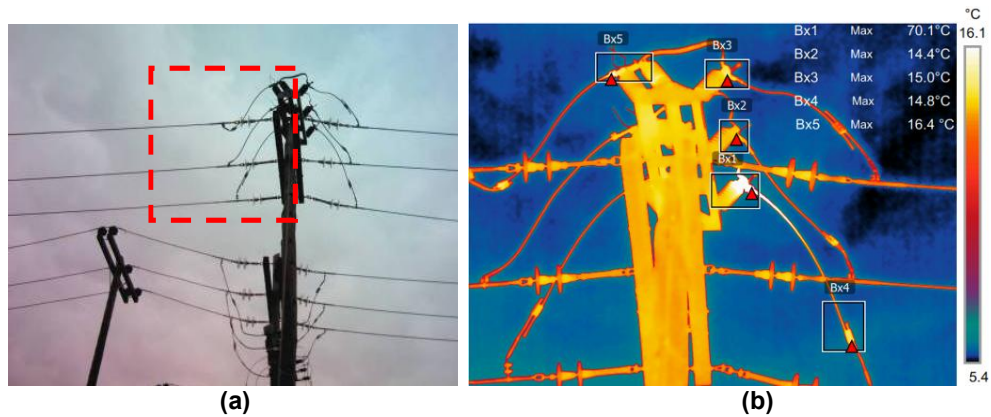
In case of a 3-pole sectionalizer the connection between bushing and conductors maybe presents a problem. These problems can cause enough heat to destroy the internal parts of the electrical equipment (Fig. 4a and 4b). In the a-phase has found a problem with the connection at the top of the bushing; as a result, this termination is showing excessive heat compared to the other two phases. The fault has priority 1. Another point which usually checks an experienced is the closure of a 3-phase knife switch. In (Fig. 5a and b) the B-phase knife switch blade is overheating at the hinged joint and this cause overheat at the whole blade. The thermal image shows a fault with priority 3.

**Fig. 4. (a) The visual photo of a disconnector and (b) the thermal photo of the same disconnector reveals the most common problem, a fault with the connection at the top of the bushing**

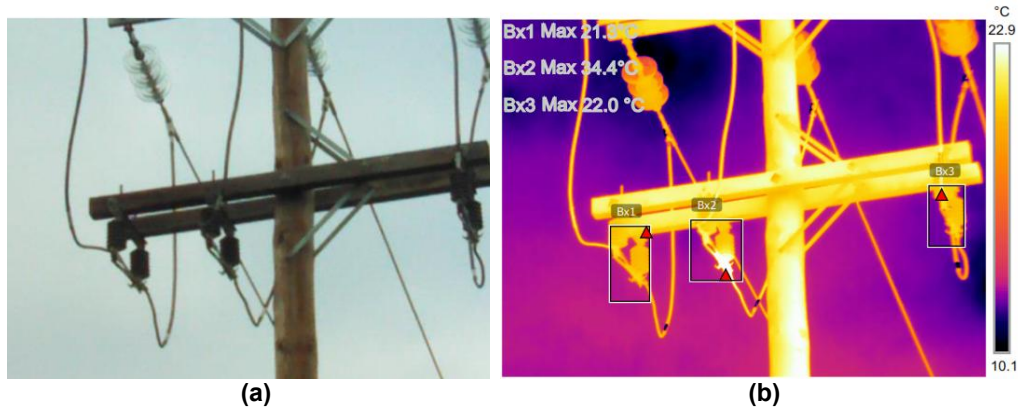
**Fig. 5. a) The visual photo of a 3-phase knife switch shows and b) the thermal photo which reveals a fault with priority 3**

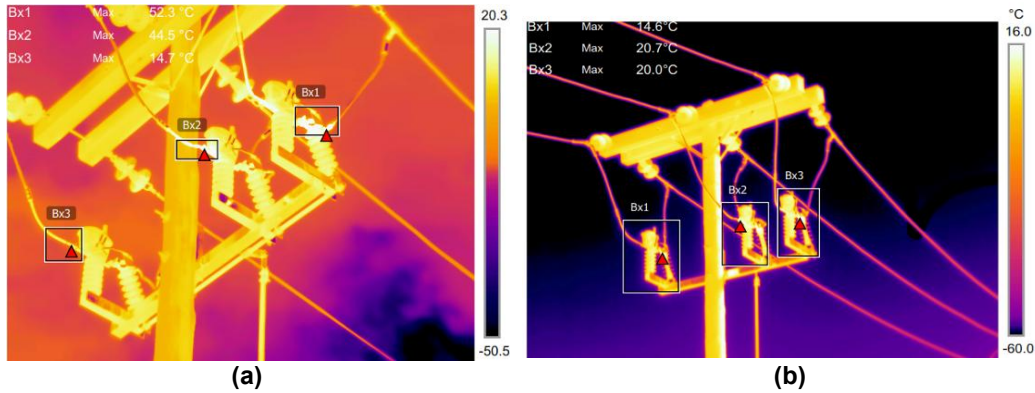
Except of these common problems, a thermographer in a live network meets and some with lower frequency. (Fig. 6a and b) shows a 3-phase switch load in which the three connections at the top of the bushings have maximum temperature 17°C, 44°C and 53°C correspondingly. The ambient temperature the

same time was about 15°C so a thermographer of the HEDNO S.A. believe that there is problem both in B and C phase at once. After linemen repair the connections, it was revealed not only that the thermographer had right but also that there was a small imbalance of the load between phase A and phase B and C. From this example infers that sometimes the combination of two thermal images, before and after the repairing damage, it is possible to give valuable extra information.

**Fig. 6. (a) the thermal photo of a 3-phase switch load reveals problems in B and C phase and (b) after repairing the fault the thermal photo shows a small imbalance of the load in A, B, C phases**

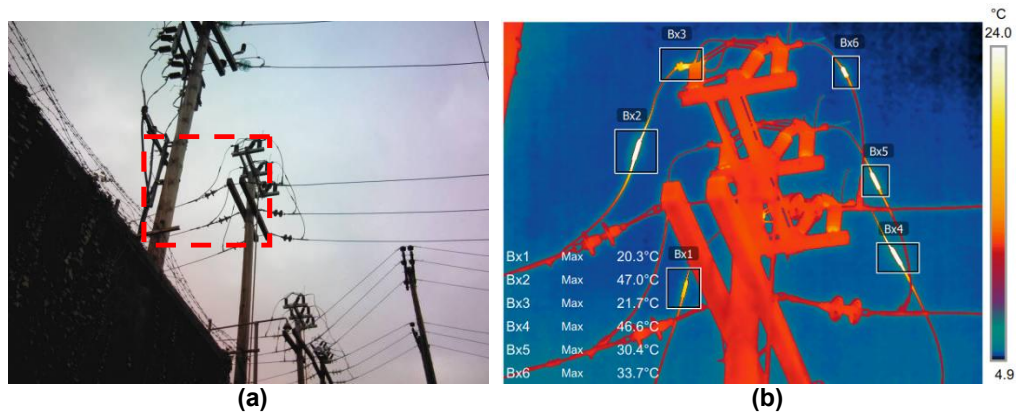
However, usually the interpretation of fault is not so evident. Then the experience and the perceptivity of a thermographer are crucial. In (Fig. 7a and b) there are 6 points with measured temperatures from 20°C up to 47°C. The thermographer compares the input and the output in each phase and successfully detects the faults in the input of A-phase and in the output of C-phase.

**Fig. 7. (a) A visual image of a 3-phase disconnector and (b) the thermal photo shows problems faults in the input of A-phase and in the output of C-phase**
