Current Journal of Applied Science and Technology

Oil Pollution Analysis of Gjanica River from Petroleum Rafinery and Production Industry in Albania

Original Research Article

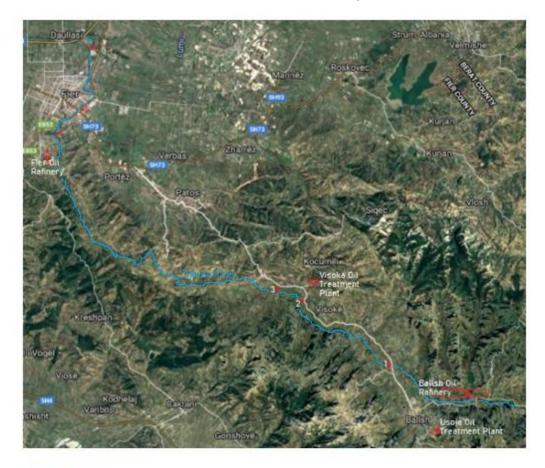
Gjanica river

Also, five riverbed sampling stations were identified (Fig. 2):

- bridge before entrance to the town of Ballsh (northern most station);
- in the Ofiçinë before the Visoka decanting plant;
- after Visoka decanting plant;
- before the bridge at the entrance of Fier's city (Gjanica river),
- at the bridge in the centre of Fier,
- Overpass of Hoxhara canal.

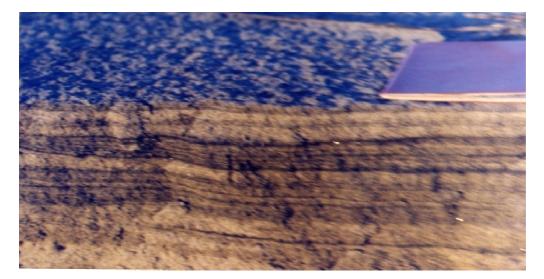
The Fig. 10 taken in river banks sediments eroded by water flow shows the history and intensity of discharges, and the amount of sediments that the river Gjanica has brought over the years. This is like a picture of the history of sediment and hydrocarbon pollution transport process.

Fig. 10. River sediments on the bank of the river Gjanica (before the bridge at the entrance of Fier)

From the chromatogram in Fig. 7 taken from the analysis of sample 4.1, sample which was taken before the bridge at the entrance of the city of Fier, we see a series of hydrocarbon deposits (Fig. 10), where the thicknesses of these sections are from 0-15 mm. In this zone we have high deposits of clays and silk.
