Performance Evaluation of Constructed Bench Terraces in Southern Zone of Tigray Region

3.1 Evaluation of Sidrkam BT in Zatta, Ofla District

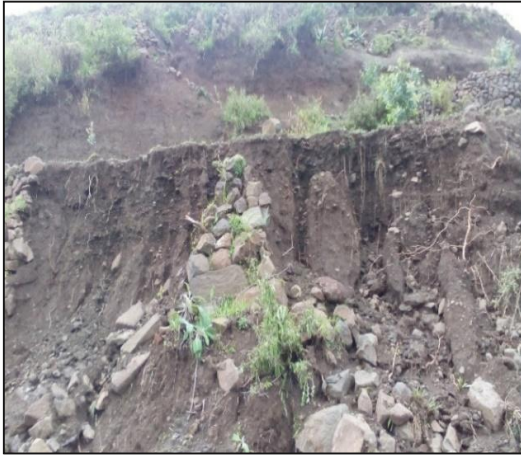
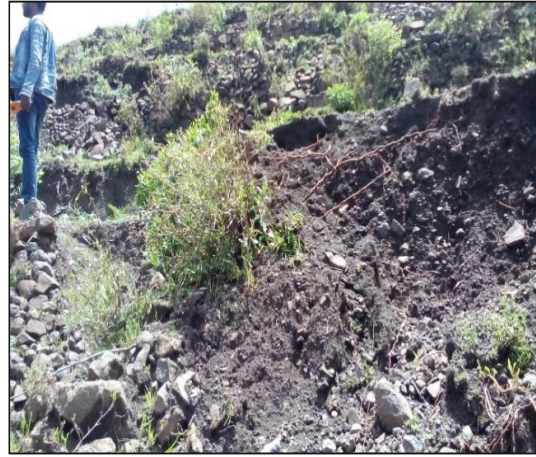
Fig. 4. Collapse of terraces due to steep slope and fragile soil

estimate the amount of earthwork required for cut and fill as well as the depth of BT [2,15,13]. Some BTs were constructed on a very steep slope (72%). There was no foundation, no buffer zone, and single-line stone placement in some BTs which makes the BT to easily collapse and unsustainable. There was a water availability problem to make it usable for the beneficiaries of that particular BT and large horizontal bed slope without waterway which can lead to damage to the BT and erosion hazard. The soil texture was inappropriate (sandy and fragile soil) leading to the unsustainability of BTs [16,11].

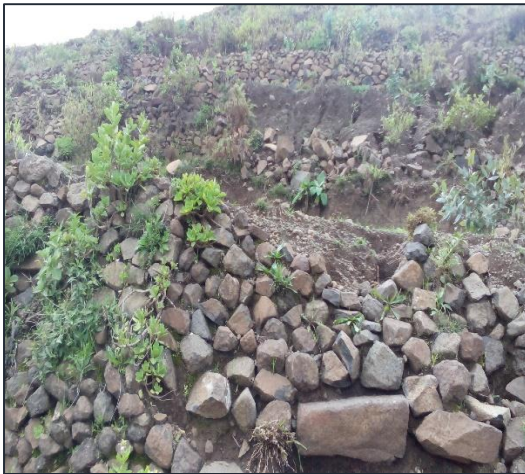
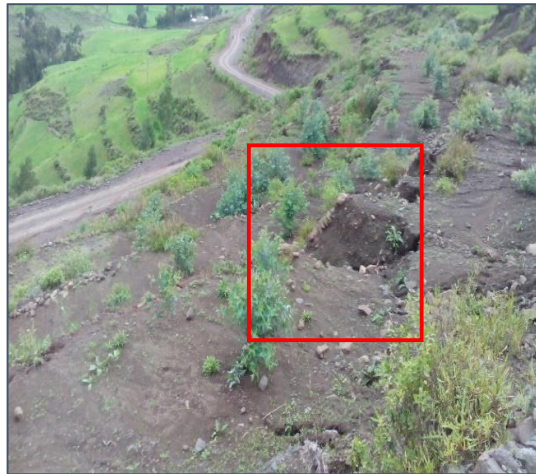
Fig. 4. Collapse of terraces due to single line stone placement, no buffer zone and not support with biological SWC practices

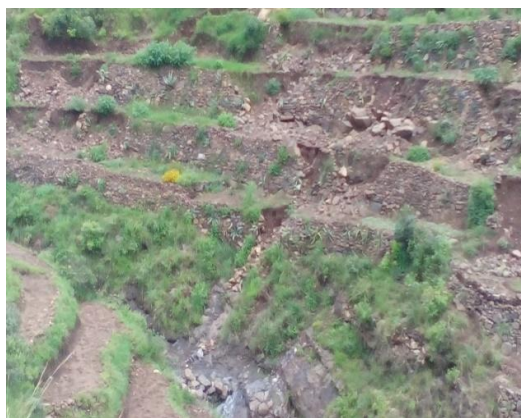
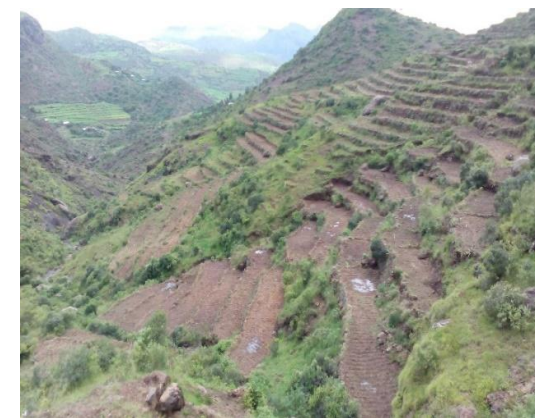
Fig. 6. Collapse of the terrace due to not recommendable slope

Fig. 7. BT supported with local biological soil and water conservation practices, chili and avocado planted

For suitable BT selection, the maximum slope for handmade BT is from 12% to 60% and should not exceed 30 degrees (60%) [12,13,14]. If the terraces are done by hand, the fitting slope range is from 7 degrees to 25 degrees (12.3% to 46.6%) [13]. However, the site in Sidrkam BT was selected on a very steep slope of an average 78% and in sandy and very fragile soil which is beyond the recommendation for the construction of BTs. The steep slope, single line BT, the sandy soil texture and large stone placement at the top of BTs resulted in the collapse of the terraces. The terraces were not supported with biological SWC measures, no buffer zone left, free grazing and no maintenance activities were done. Almost all structures were collapsed forming gullies and changing to degraded land. There was no water source for the terrace and eucalyptus was planted on the terraces which were not the target of constructing BTs. It takes a long time to get benefits from the perennial crops thus raising questions of economic feasibility and the maintenance and sustainability of the BT could be at risk.

The BT in Firkaba has no waterways, no buffer zone in some BTs and there is a collapse of structures in some steep slope (80% slope) areas. Avocado and chili were planted but production was not started yet since the water source is not sustainable and fully functional. However, BT was supported by local biological SWC practices such as '*Oleo berhana*' and '*Becium grandiflorum*'.

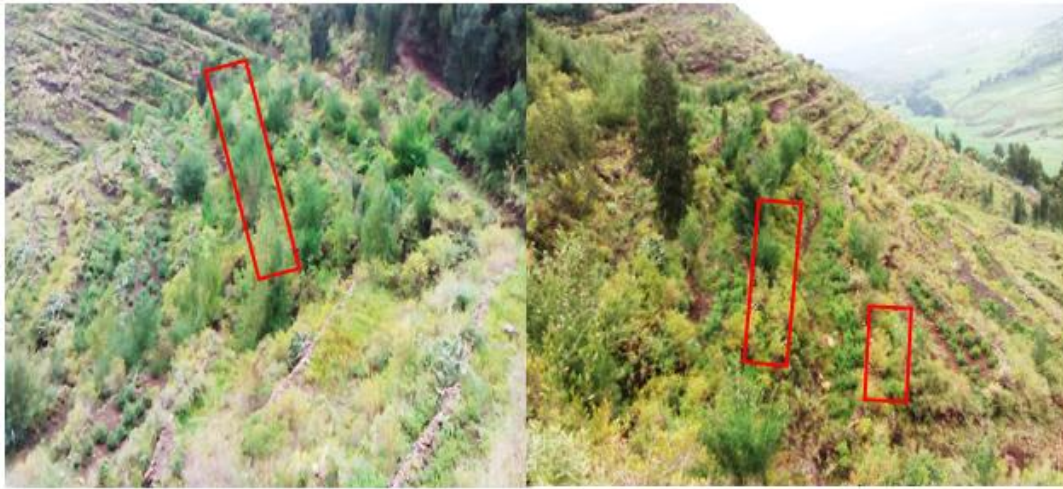
Fig. 8. BT supported with Biological SWC practices, animal fodder trees and with a good buffer zone

This BT was relatively more stable BT than other BTs found in the southern zone of Tigray region. It is supported by biological SWC grasses such as Vetiver, Desho, Elephant grasses and acacia species which can be used as animal fodder and some local biological shrubs and grasses. There is a better sense of ownership and maintenance of the BTs compared to all other BTs constructed in the southern zone of Tigray region. Enough buffer zones were left in most of the BTs which is good for the stability and sustainability of the BTs. It can be taken as a model for other BTs. However, since the area of the buffer zone is wider it is recommended to cover with economically important grasses, shrubs, and trees rather than making it as free space [4,9]. In some BTs the infertile soil has been changed to the production of cash crops such as *Rhamnus prinoides*, Potato, Onion, and Carrots due to good management and soil fertility enhancement practices. Economic benefits have been started in a member of 20 groups from *Rhamnus prinoides*, Onion, Carrot and animal fodder from the acacia trees and biological grasses. Planting biological SWC grasses/measures at the top and base of the BTs is recommended for better stability of BTs. However, water availability is the major problem in almost all BTs and the acacia species are rarely used for animal forage and this has to be changed to benefits.

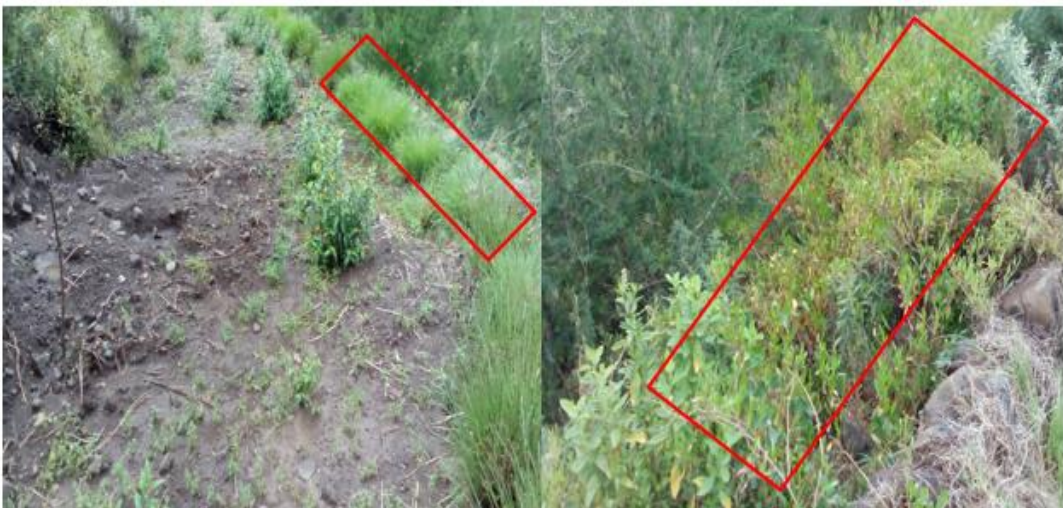
Fig. 9. BT planted with cash crops and supported with biological grasses, shrubs, and trees (both local and exotic species)
